Management of horizontal root fractures at various levels: A case series

James David Raj, Sindhu Ramesh, S. G. Khirtika

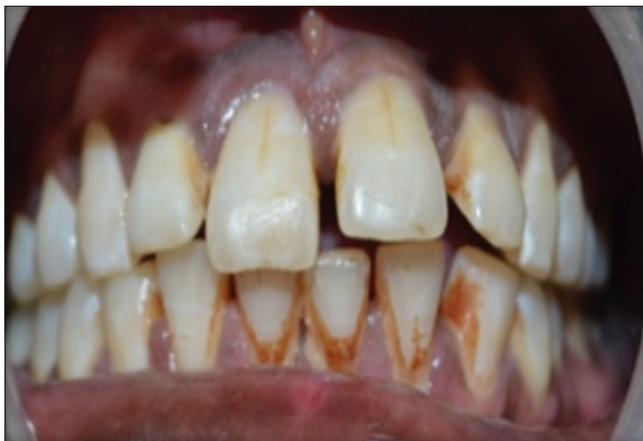
Figure 1: Pre-operative photograph showing palatally tipped left central incisor

1 week. The patient also reported that he met with a road accident when he skids off road as he lost control of his motorbike. Extraoral examination revealed lacerations on the lip and suture has been placed by a General Physician [Figure 1]. The intraoral examination revealed Grade II mobility in 11. Intraoral radiographs revealed radiolucent line at the apical third of 11 suggesting horizontal root fracture in the apical third of 11. Electric pulp test, heat test, and cold tests gave a negative response, but this initial lack of response to these tests in traumatized teeth does not imply an irreversible damage to the pulp.^[9]

Under local anesthesia, the tooth was repositioned using gentle digital manipulation. Rigid splinting of teeth was done using 0.7 mm stainless steel wire and composite resin.

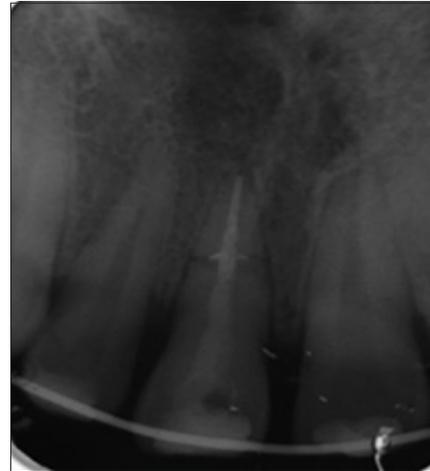
Figure 2: Endodontic treatment followed by fiber-reinforced composite post placement

The patient was put on analgesics and was advised to avoid mastication in the area. 4 weeks after the first visit, the patient returns to the office with intraoral swelling and pain in relation to 11. Still, there was no response to the EPT, heat and cold test which revealed complete necrosis of pulp. Therefore, root canal therapy was initiated. Obturation was done using Gutta-percha points and MTA Fillapex sealer, Angelus. The following week, using the peeso reamers, post space was prepared. Canal was conditioned with 37% phosphoric acid, bonding agent applied and cured for 20 s, and FRC post was treated with Monobond-S (Silane coupling agent) finally luted with RelyX arc, 3M ESPE dual cure cement [Figure 2]. Composite entrance filling was given in Figure 3.

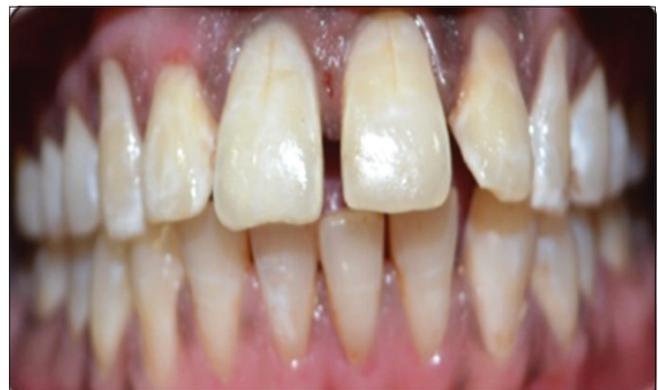
Figure 3: Post-operative photograph

After 90 days, the right maxillary central incisor's mobility was regarded as normal; thus, the splint was removed. After 1 year of clinical and radiographic follow-up, tooth presented no symptoms and radiographic pathology suggesting a repair of root fractures.

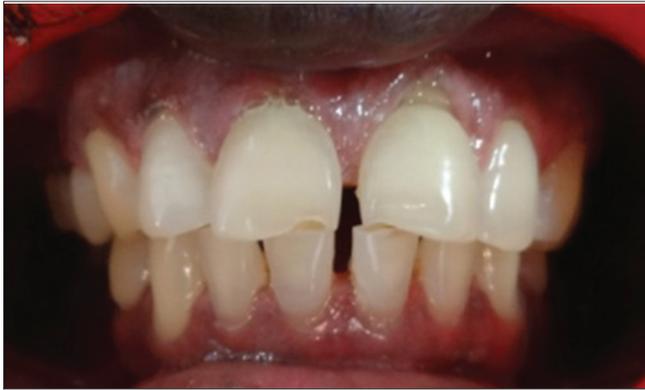
process, this trauma occurred. No extraoral findings were seen. The intraoral examination revealed Grade II mobility in 11. Intraoral radiographs revealed radiolucent line in the middle third of the root of 11 suggesting horizontal root fracture in the middle third aspect of the root of 11. Electric pulp test, heat test and cold tests gave negative response.

Figure 4: Pre-operative photograph showing fractured left central incisor

Under local anesthesia, the teeth were repositioned using gentle digital manipulation. Temporary semi-rigid splinting was given in relation to upper anterior (13-23) using 0.7 mm stainless steel wire and composite resin for a period of 12 weeks.

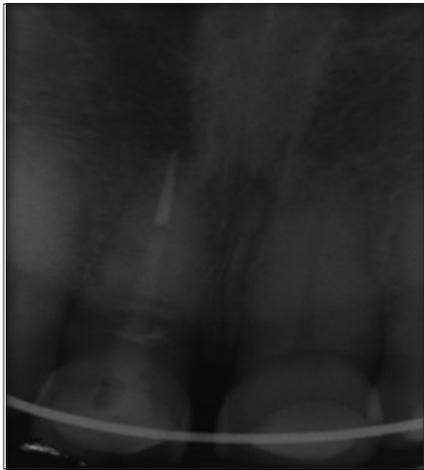
Figure 5: Endodontic treatment followed by FRC post placement

The patient was put on analgesics and was advised to avoid mastication in the area. 1 week later, the patient returns to the office complaining of pain in relation to 11. EPT and thermal tests showed a negative response in 11 which revealed complete necrosis of pulp. Hence, root canal therapy was initiated. Obturation was done using Gutta-percha points and MTA Fillapex sealer, Angelus by lateral condensation technique. The following week, using the peeso reamers, post space was prepared. Canal was conditioned with 37% phosphoric acid, bonding agent applied and cured for 20 s, and FRC post was treated with Monobond-S (Silane coupling agent) finally luted with RelyX arc, 3M ESPE dual cure cement [Figure 4]. Composite entrance filling was given in Figure 5.

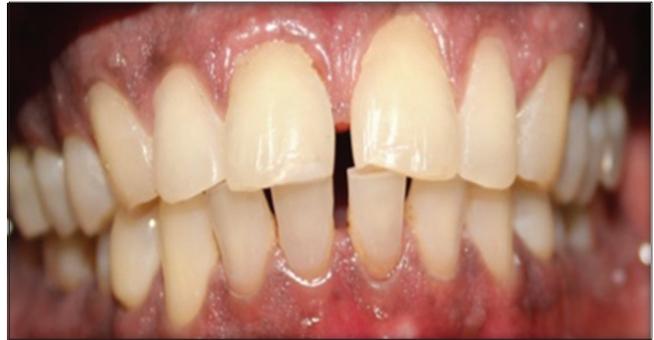
Figure 6: Post-operative photograph

Splint was removed at the end of 3 months (12 weeks). After 1 year of clinical and radiographic follow-up, tooth presented no symptoms and radiographic pathology suggesting a repair of root fractures (Figure 6).

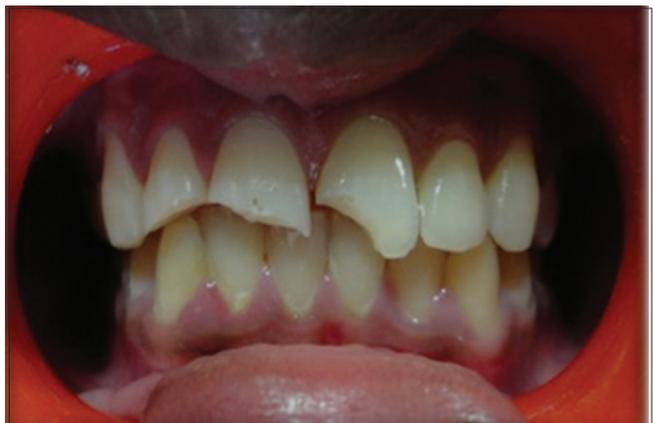
University, Chennai, India, with a complaint of pain and mobility in the upper front tooth for the past 2 days [Figure 7]. The patient also reported that he met with a road accident when he was riding his bike back home and got hit by a car. No extraoral findings were seen. The intraoral examination revealed 21 fracture of 12, 11, and Intraoral radiographs revealed a radiolucent line involving the Coronal third of 11 suggesting horizontal root fracture in the Coronal third aspect of 11. Electric pulp test, heat test, and cold tests gave negative response.

Figure 7: Pre-operative photograph showing fractured left central incisor

Under local anesthesia, the teeth were repositioned using gentle digital manipulation. Temporary semi-rigid splinting was given in relation to upper anterior (13-23) using 0.7 mm stainless steel wire and composite resin for a period of 12 weeks.

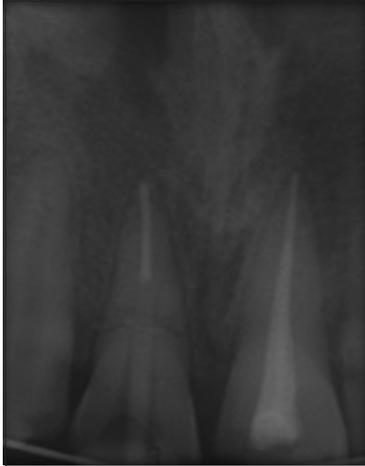
Figure 8: Endodontic treatment followed by FRC post placement

Root canal therapy was initiated. Obturation was done using Gutta-percha points and MTA Fillapex sealer, Angelus by lateral condensation technique. The following week, using the peeso reamers, post space was prepared. Canal was conditioned with 37% phosphoric acid, bonding agent applied and cured for 20 s, and FRC post was treated with Monobond-S (Silane coupling agent) finally luted with RelyX

arc, 3M ESPE dual cure cement [Figure 8]. Composite entrance filling was given, crown preparation was done, and Ceramic crown was cemented in 21, 11 [Figure 9].

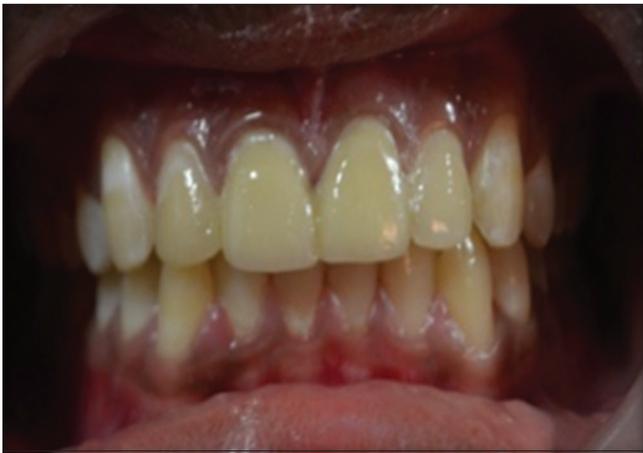
Figure 9: Post-operative photograph

Splint was removed at the end of 3 months (12 weeks). After 1 year of clinical and radiographic follow-up, tooth presented no symptoms and radiographic pathology suggesting a repair of root fractures.
